Debris/Ice/TPS Assessment And Photographic Analysis For Shuttle Mission STS-48

November 1991

Gregory N. Katnik
NASA/Kennedy Space Center

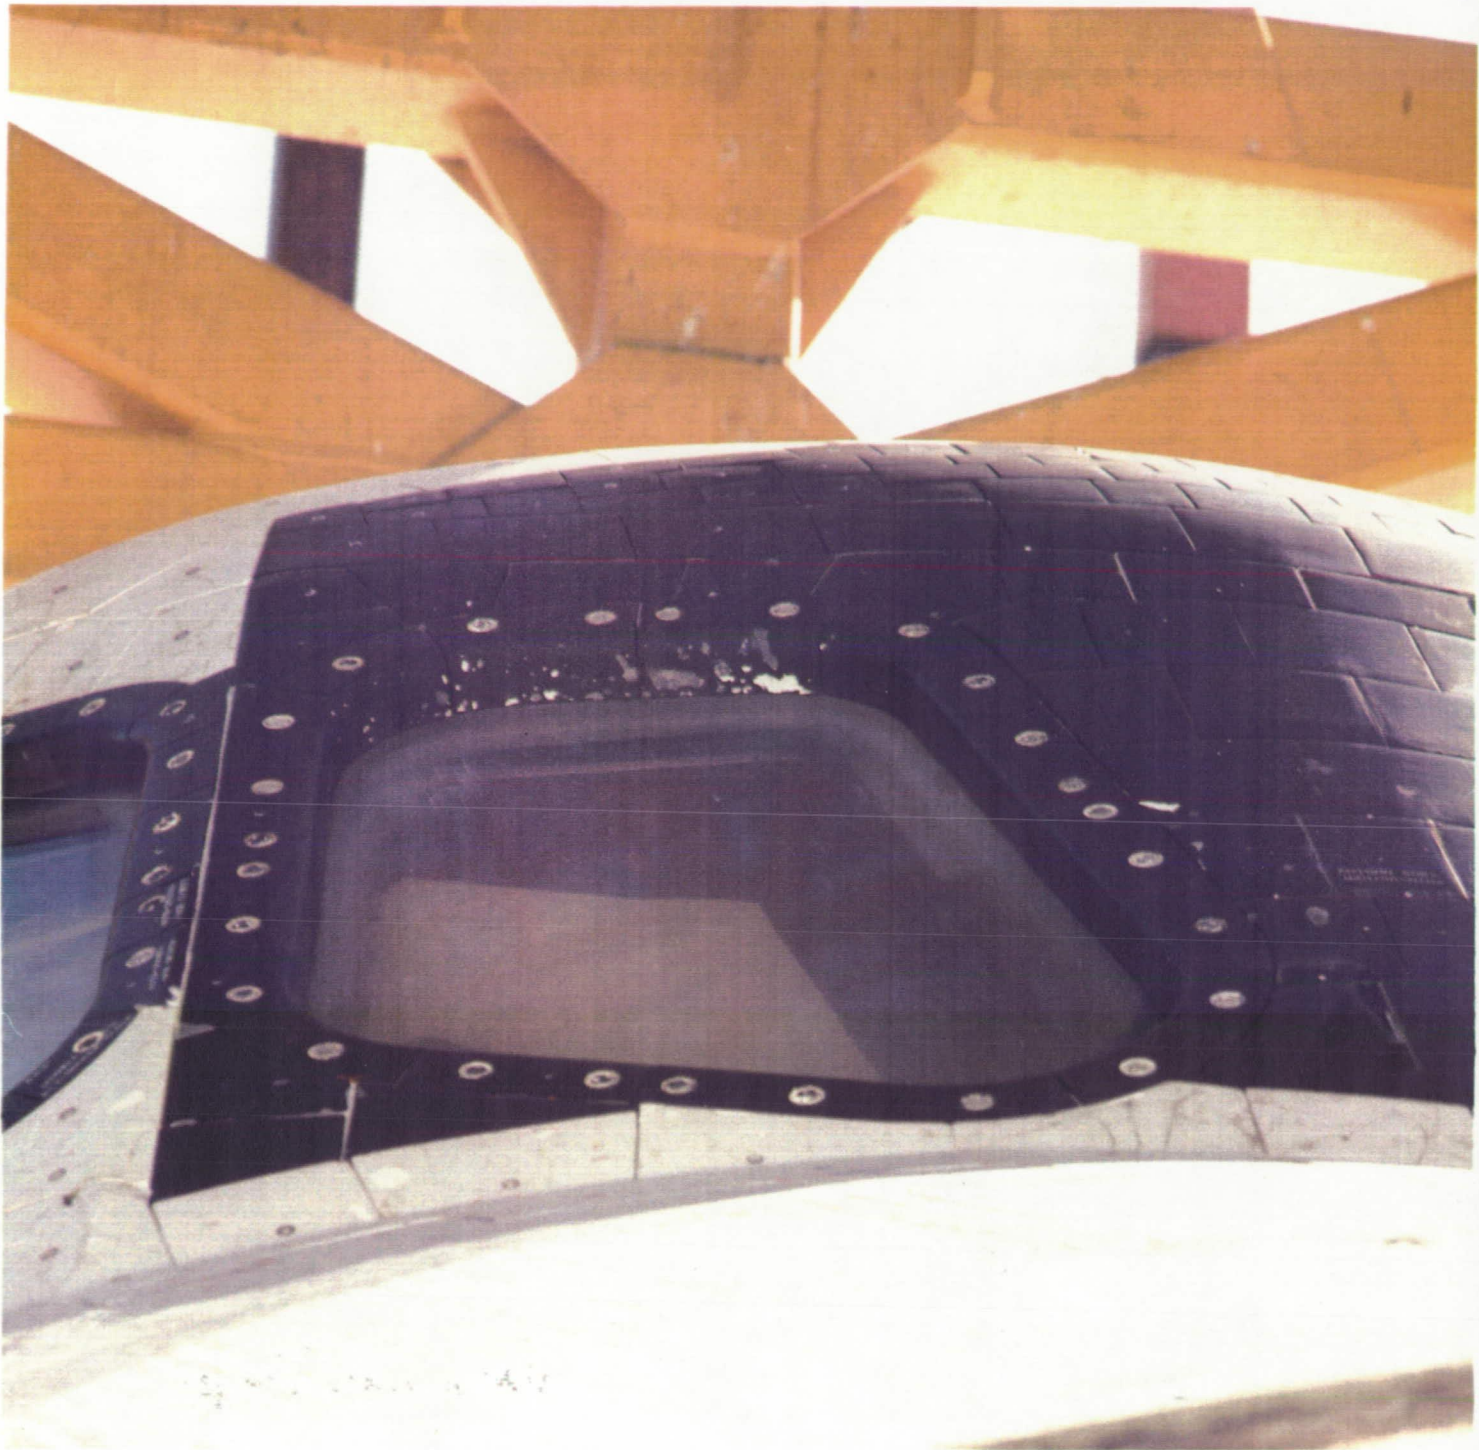
Orbiter windows #5 and #6 were lightly hazed. Window #4 exhibited moderate to heavy hazing and had numerous streaks. A greater than previously observed number of damage sites occurred on the perimeter tiles of windows #1-#6. Most of the impact sites did not exceed a depth of 1/16th inch. This damage may have been caused by the RTV used to bond paper covers to the FRCS nozzles.

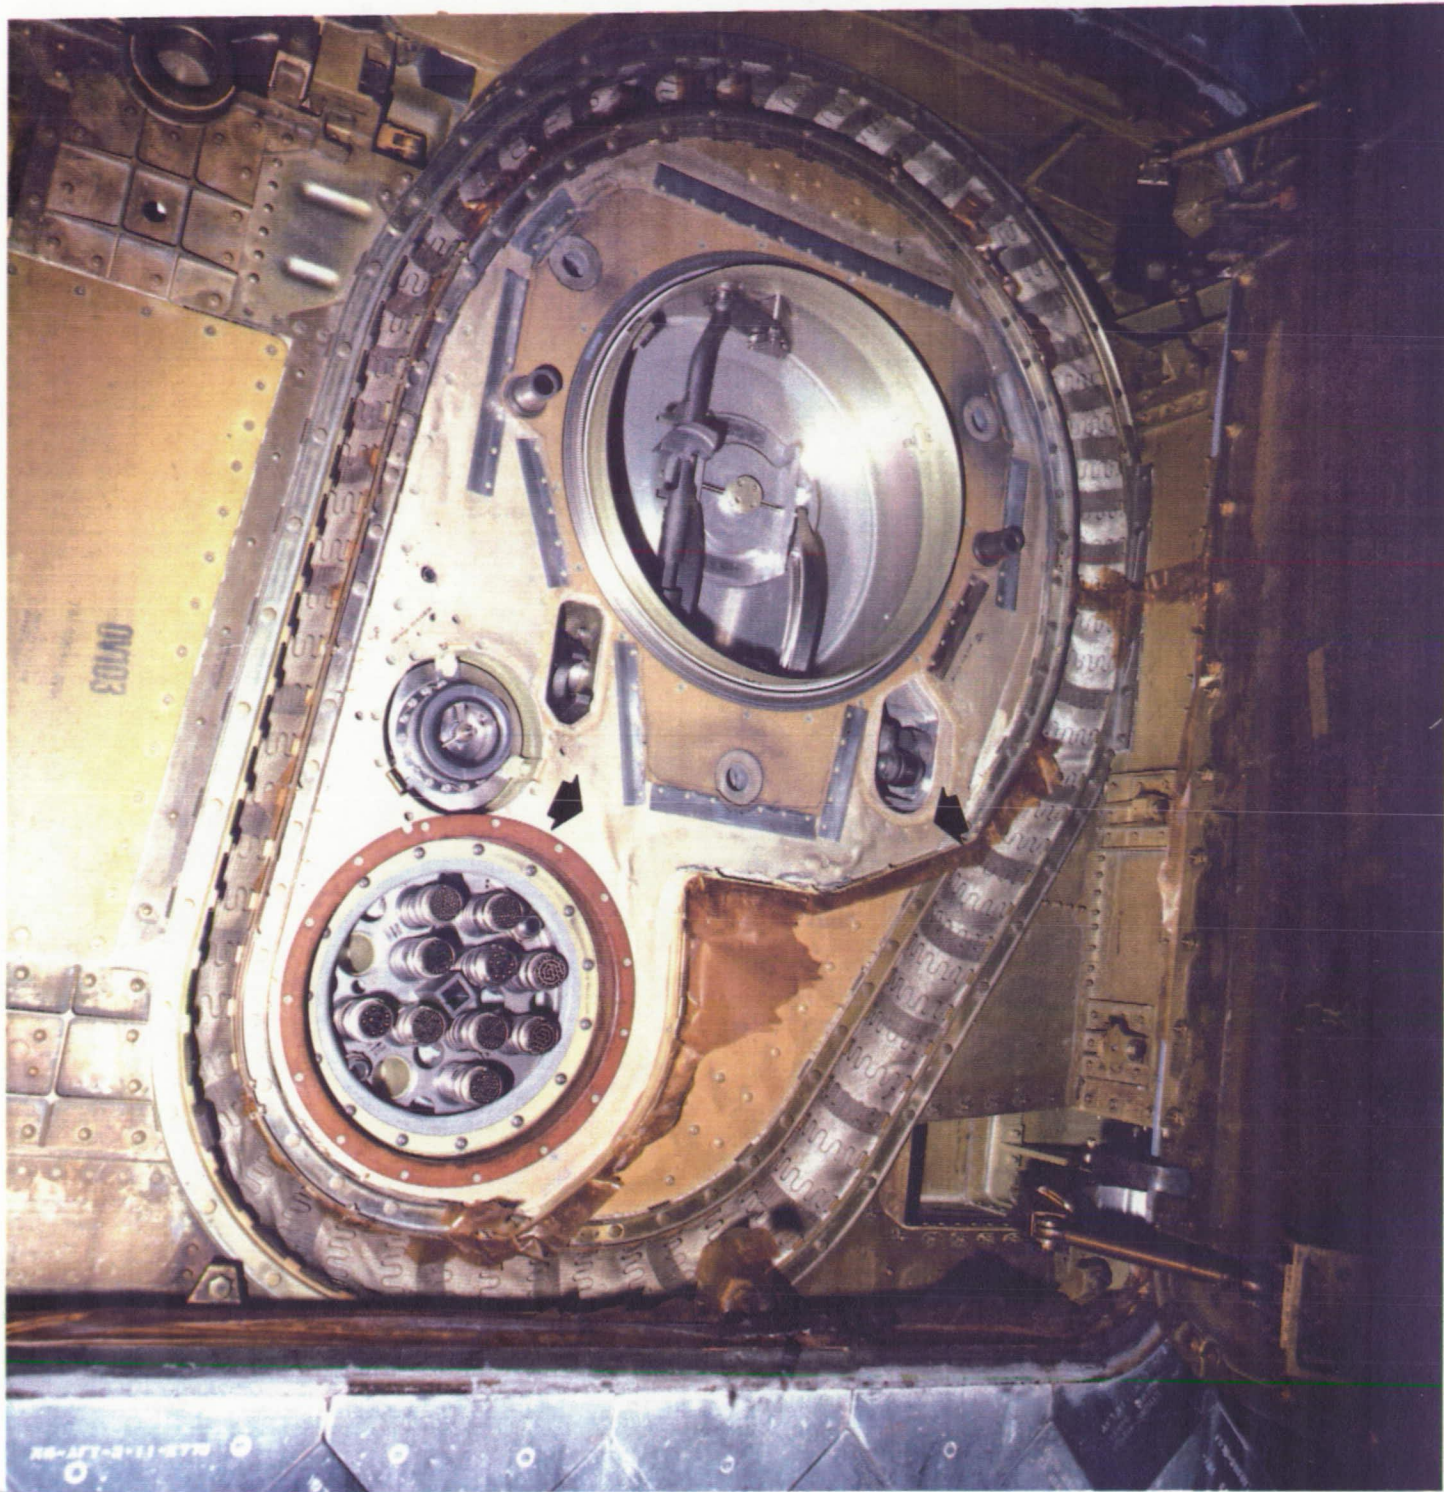
Overall view of the L02 ET/ORB umbilical. The separation ordnance device debris plunger in EO-3 was seated and appeared to have functioned properly. Wrinkling of the umbilical face plate (arrow) was probably caused by material shrinkage during cryo load and was not considered to be an anomaly.

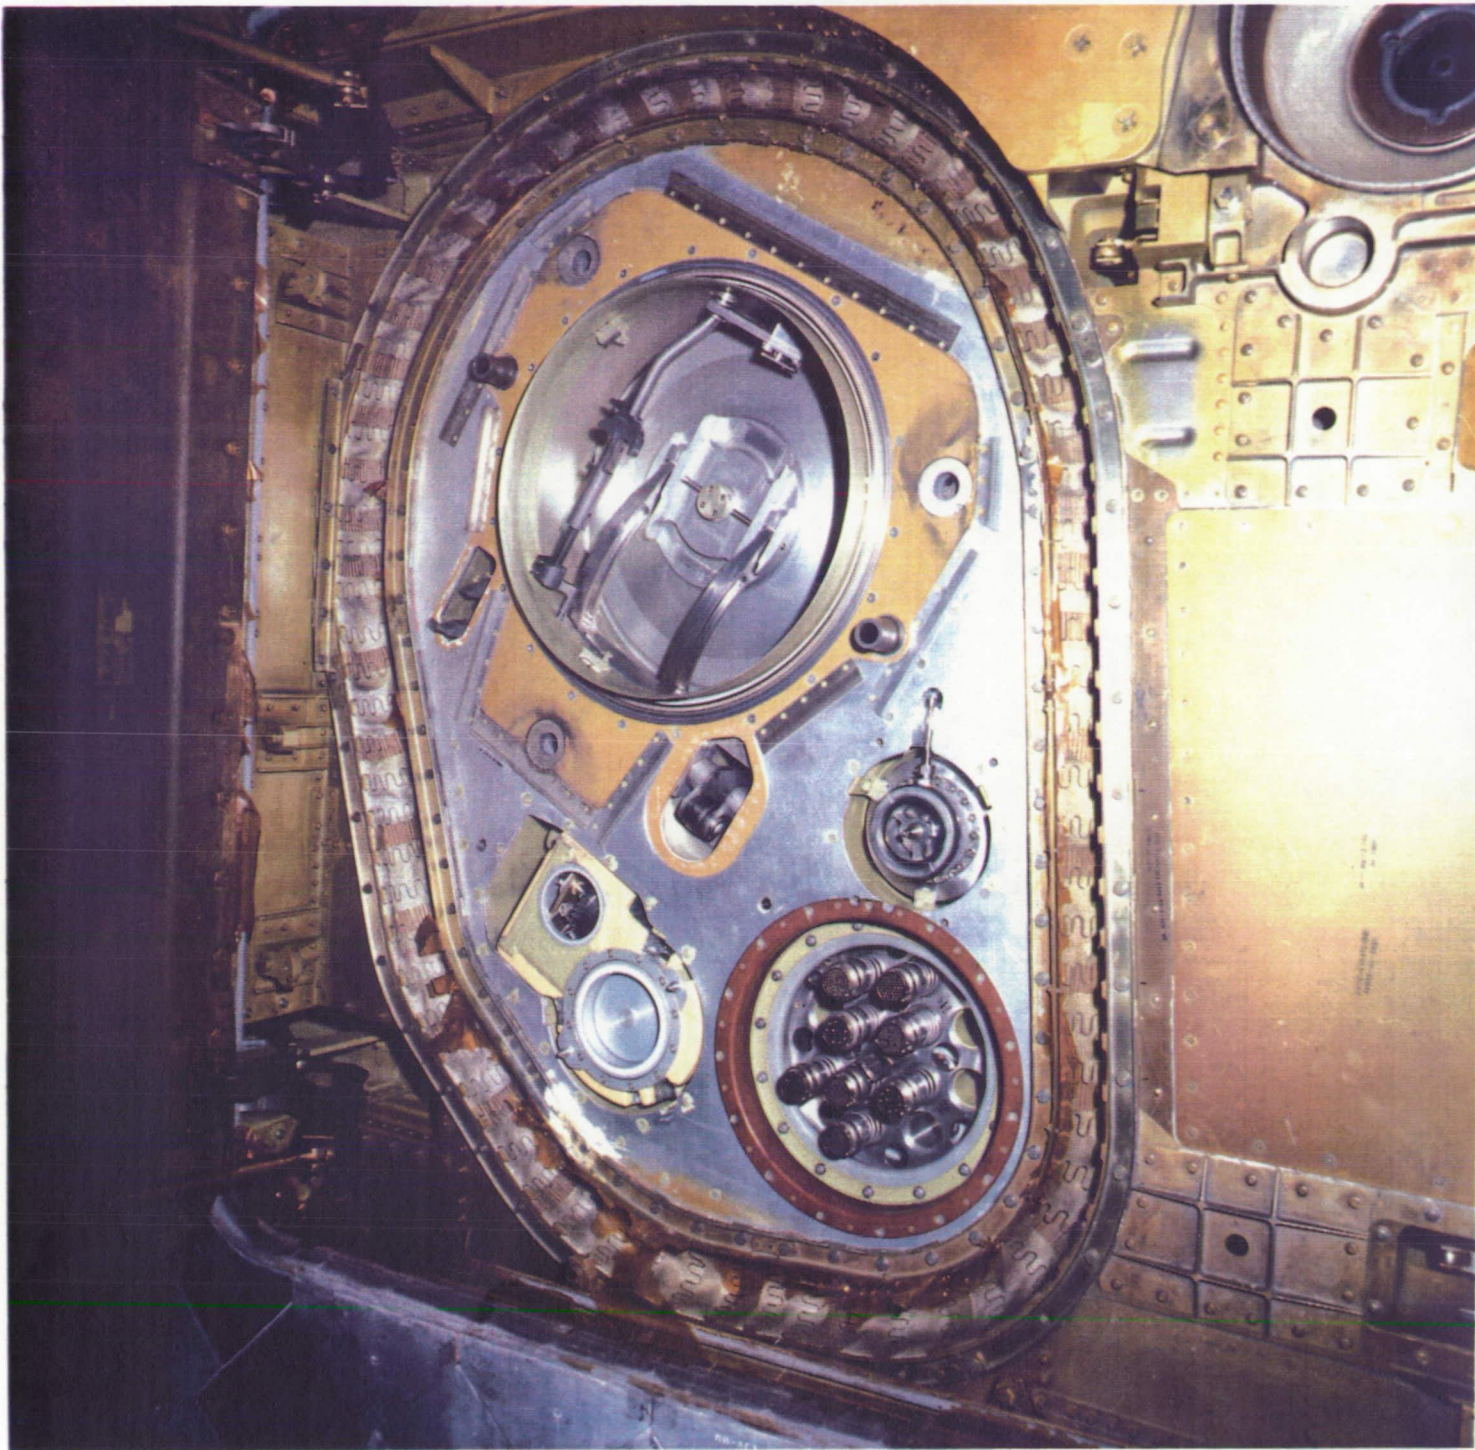
Overall view of the LH2 ET/ORB umbilical. The separation ordnance device debris plunger in EO-2 was seated and appeared to have functioned properly. There was no significant heat intrusion past the ET door thermal barrier.
